Technical Preservation Services
Preservation Assistance Division
National Park Service
U.S. Department of the Interior
Washington, D.C.

Interpreting the Secretary of the Interior's Standards for Rehabilitation

Volume III

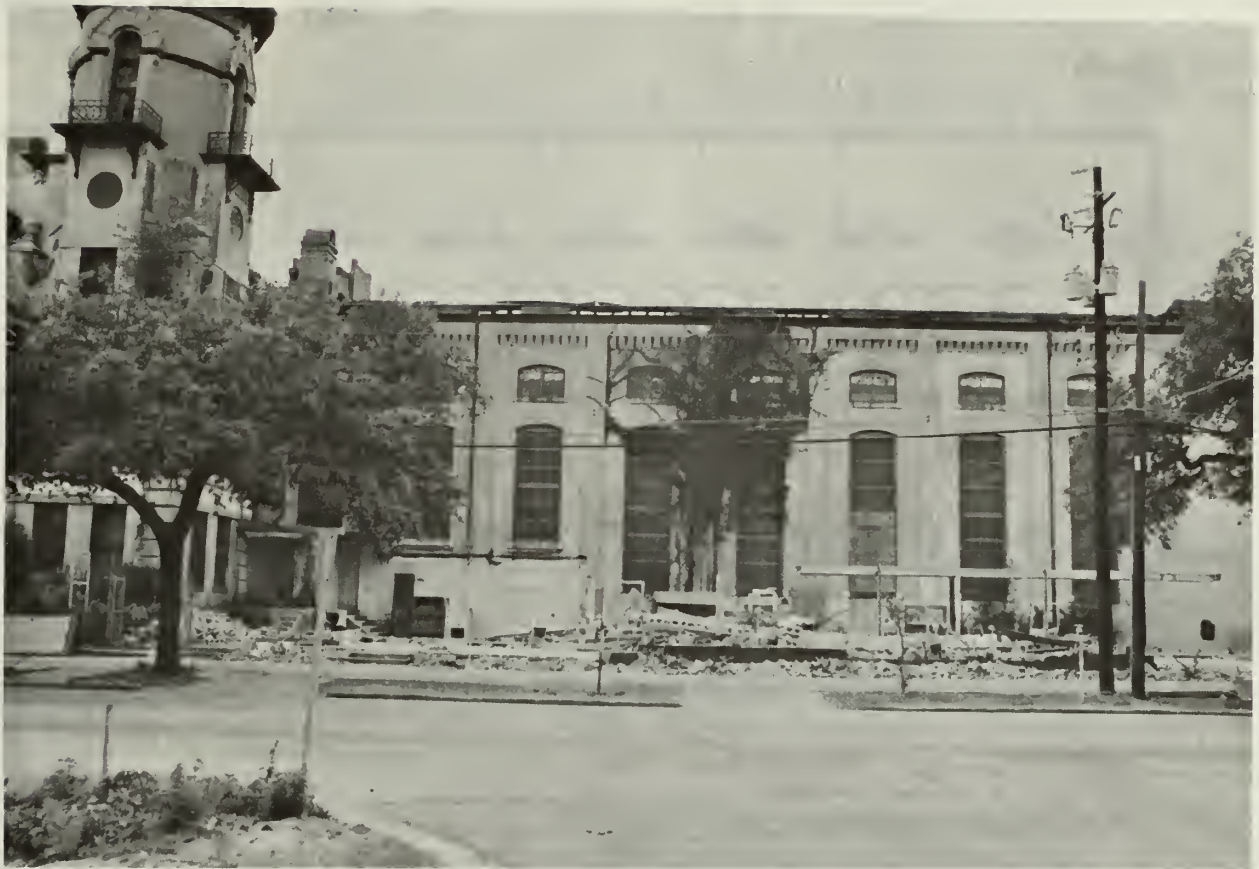
1. The property undergoing rehabilitation consisted of a three-story warden's house (partially visible, left) and a four-story cell block.

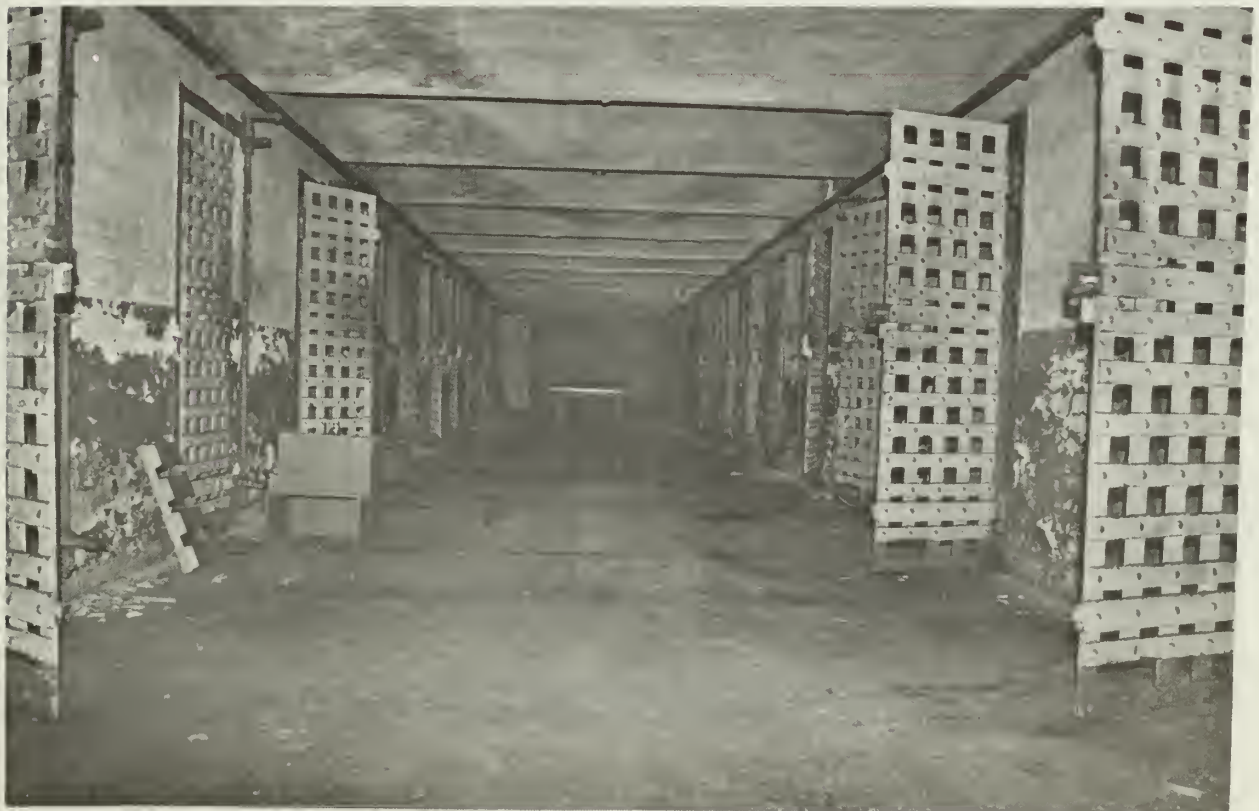
2. Interior of the cell block. Cells were 5' x 8', separated by 18" load-bearing walls.

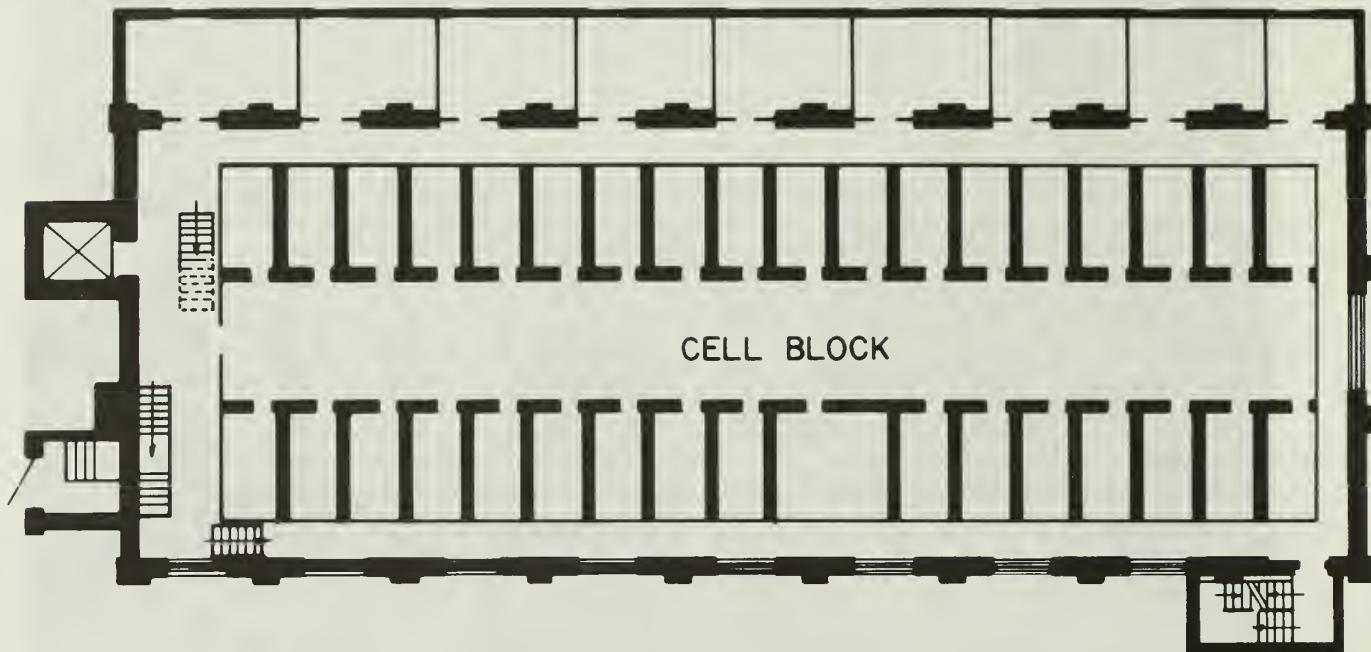
3. Floor plan before rehabilitation. Section at top of page added in the 1950s.

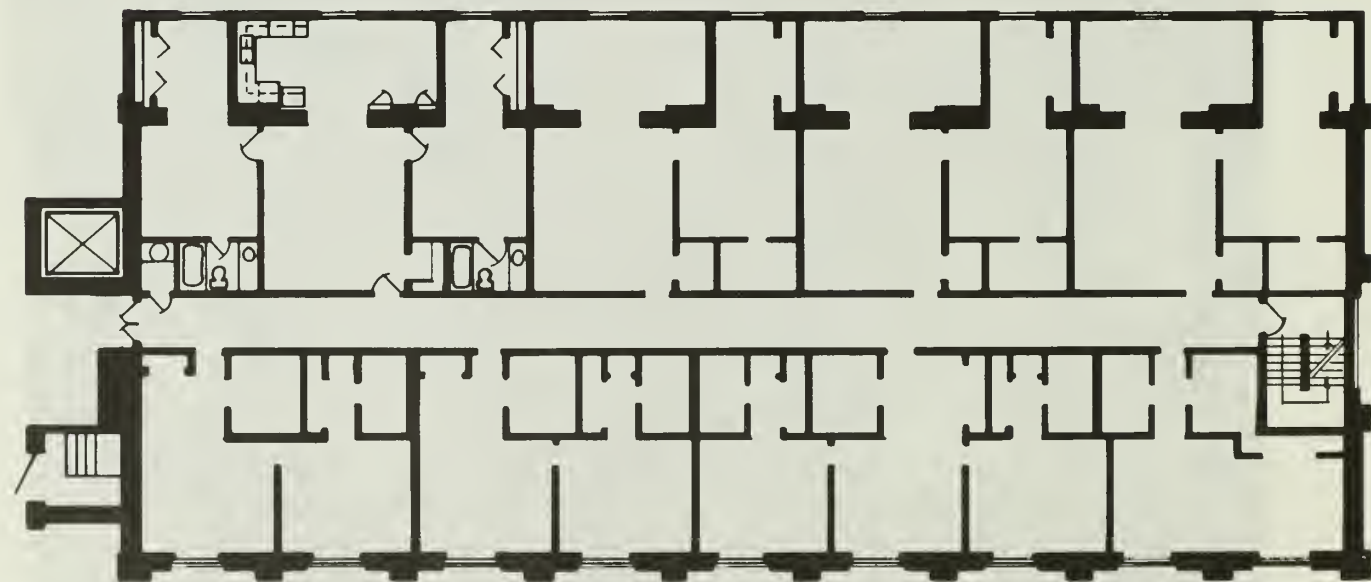
4. Floor plan showing proposed insertion of apartments and removal of nearly all interior fabric.

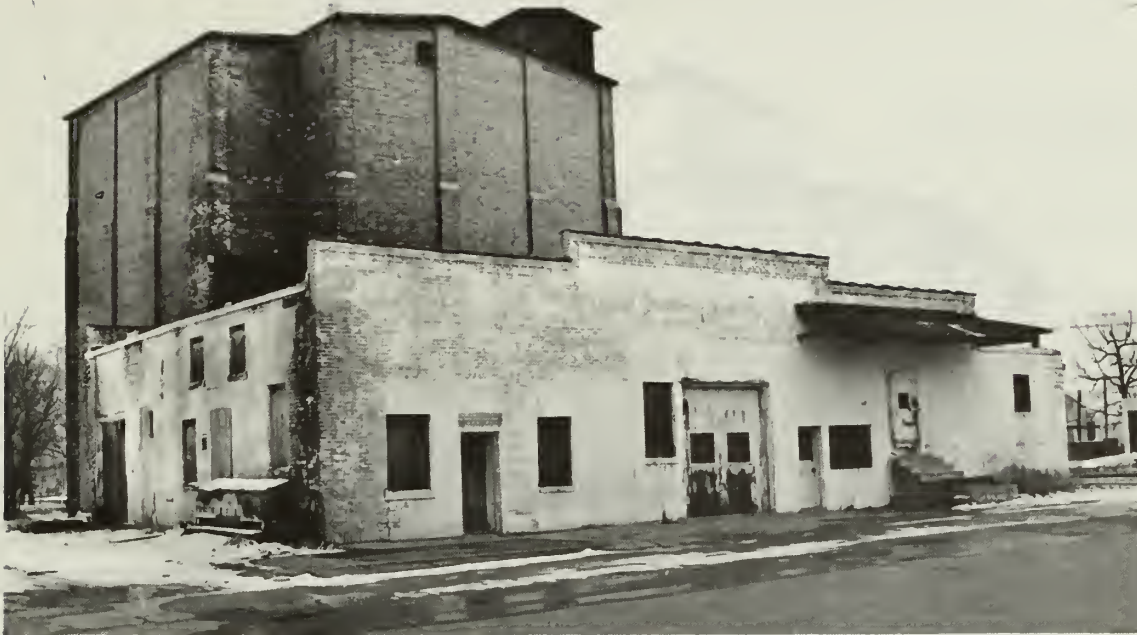
1. The historically important 1920s ice company firm consisted of a low rectangular structure together with a 50 foot high, ice storage house. Neither structure may seem to be of particular architectural "attraction." The simplicity of construction and lack of decorative detailing, however, parallel a specific use for that period of our commercial history.

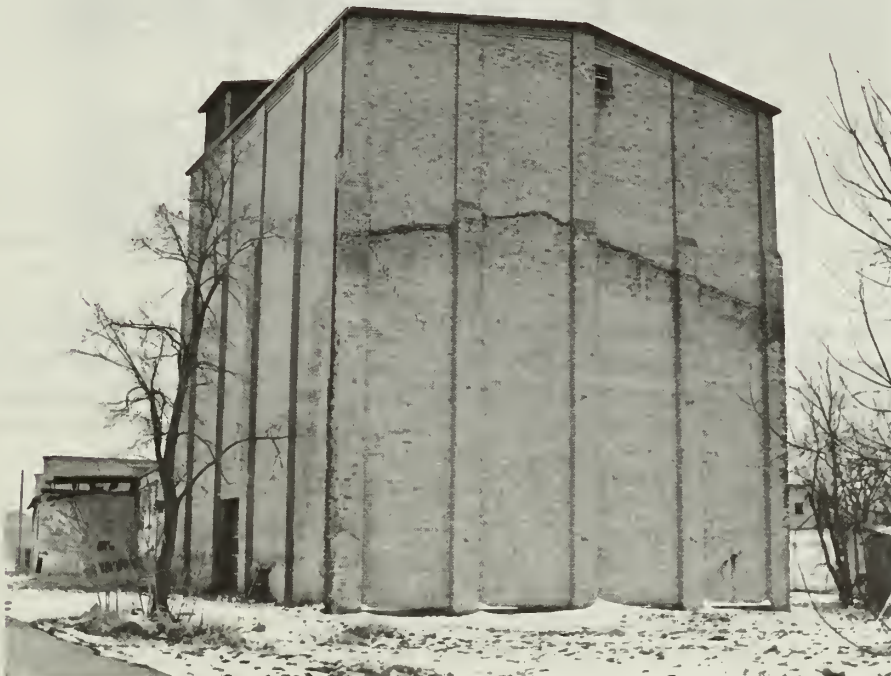
2. Ice storage house prior to rehabilitation. The massive brick structure was historically designed and constructed to be windowless on all four sides in order to enhance thermal efficiency. (The one opening seen near the top of the building is a small attic vent).

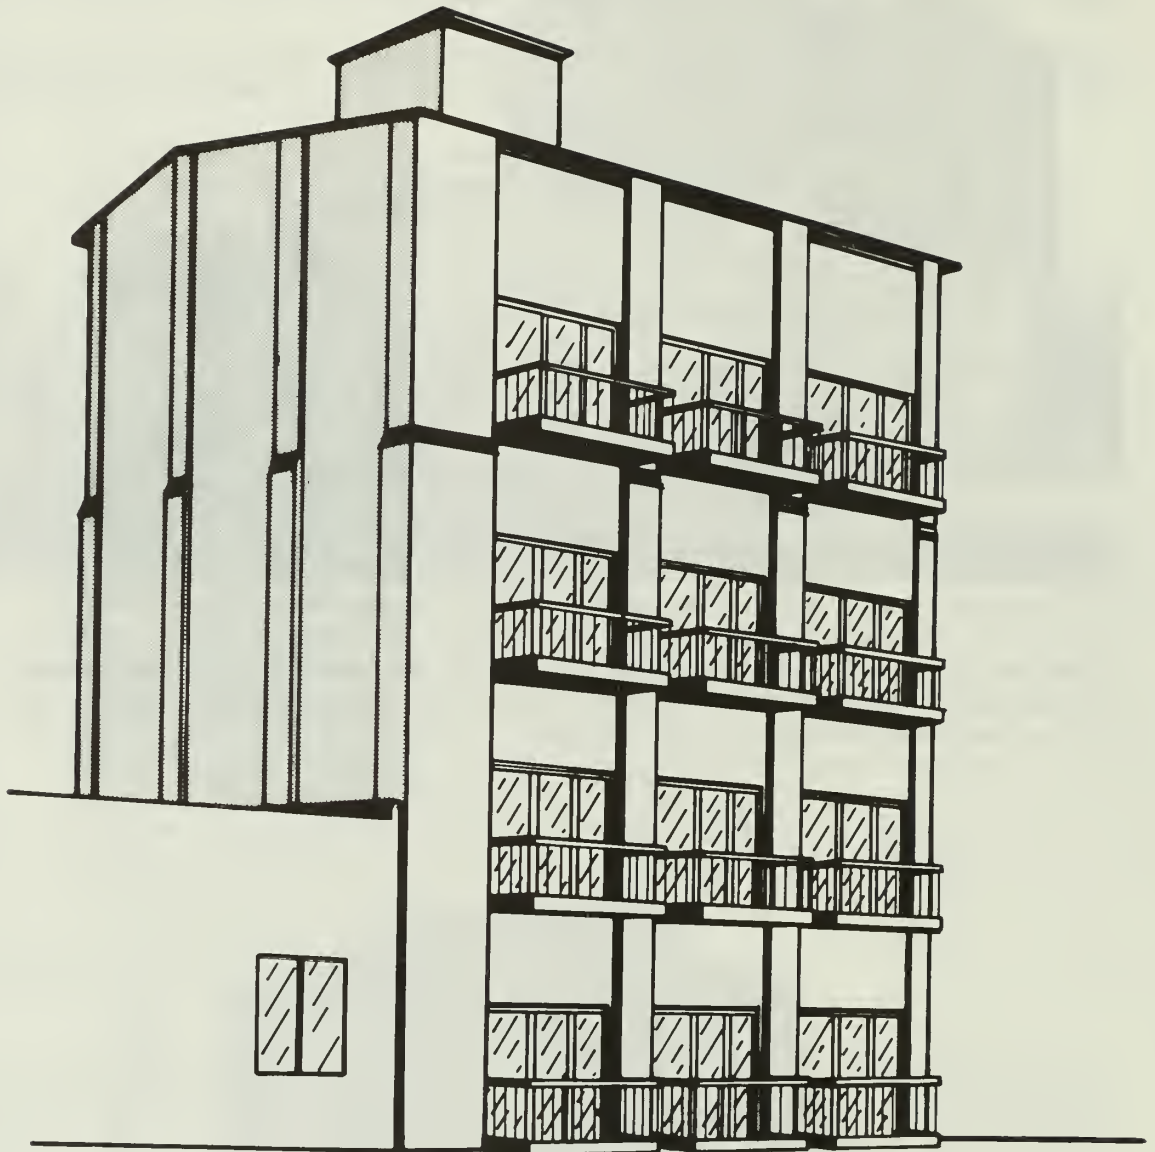
3. The rehabilitation proposal involved cutting windows on two highly visible side elevations and adding balconies. The National Park Service determined that the degree of change to accommodate this particular re-use proposal was not consistent with the historic character of the building; thus, approval was denied.

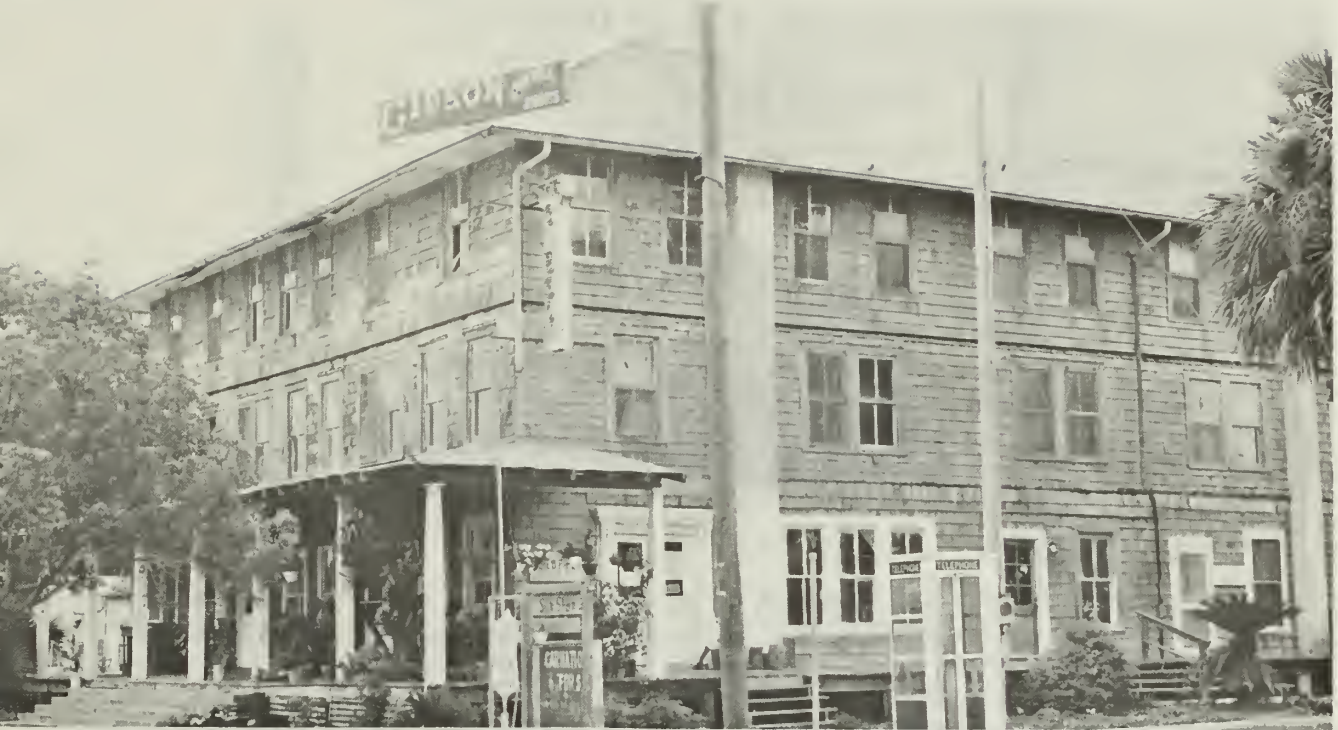
2. The hotel in 1984, prior to rehabilitation. The cupola and dormers are missing, and although a one-story front porch spans the primary elevation, it bears little resemblance to the two-story historic porch shown in the 1907 photograph. The hotel was certified as contributing to the significance of the historic district in its existing condition.

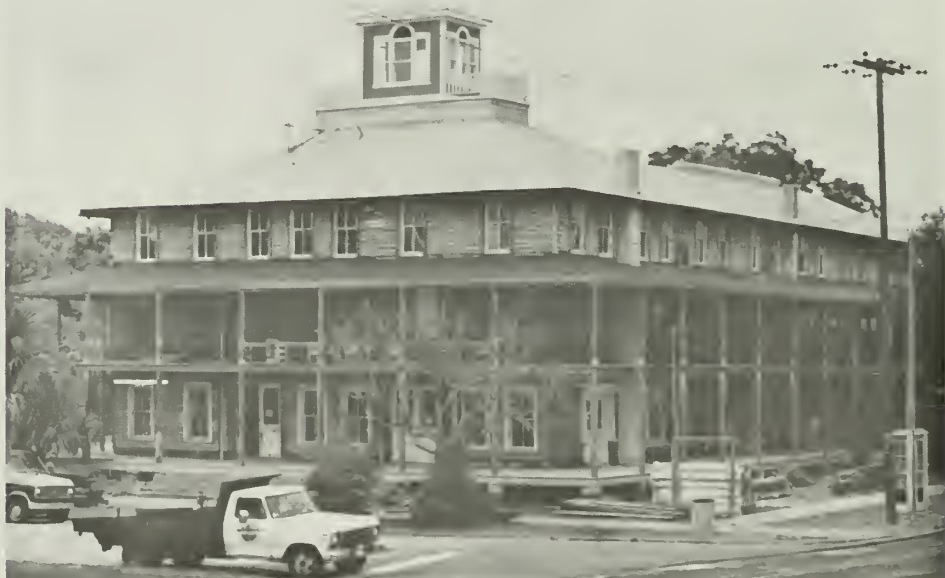
5. Hotel under rehabilitation for tax benefits. The restored cupola and two story front porch can be seen. On appeal, the Region's denial was upheld. There was neither photographic documentation nor physical evidence to support restoration of the building to the appearance shown here. The result was a "selective" restoration of architectural features that--while commercially appealing--could not be historically documented to the 1907 or the 1920 appearance.

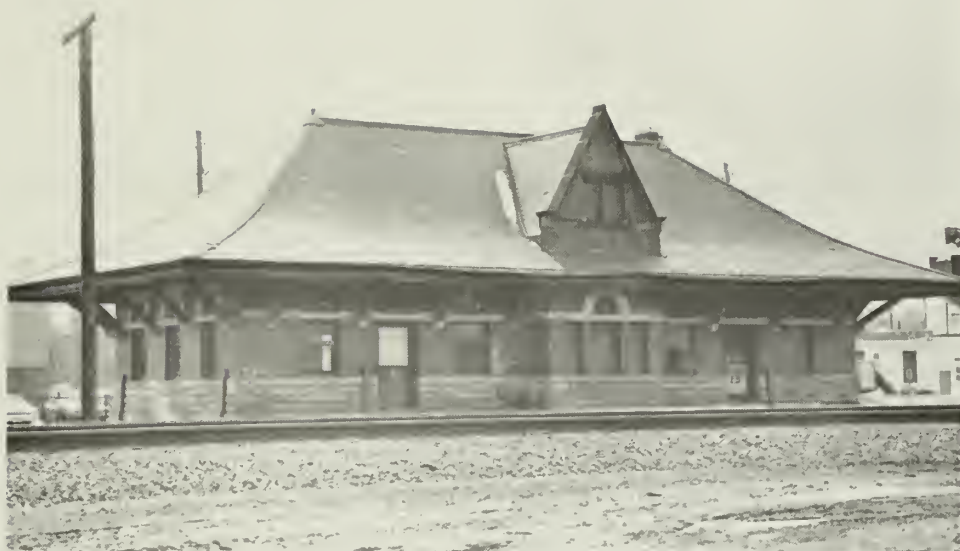
1. Pre-rehabilitation view of building from railroad tracks: Note brackets, stone corbels and stringcourses. These features occur on all sides of the building.

Application: A small, circa 1900 railroad depot which is individually listed on the National Register was rehabilitated as a restaurant. The character and picturesque quality of this depot prior to rehabilitation (see illus. 1) was largely defined by the conspicuous, slate-covered, hipped roof that projected broadly beyond the exterior walls to shelter the station's platform. The exterior walls on four sides of the building were decoratively treated with a quarry-faced limestone foundation, smooth red brick, and limestone stringcourses and window moldings. The use of these multi-colored materials and architectural features such as arched windows, leaded glass transoms, and wood brackets on stone corbels served to link the visually rich exterior walls with the prominent roof.

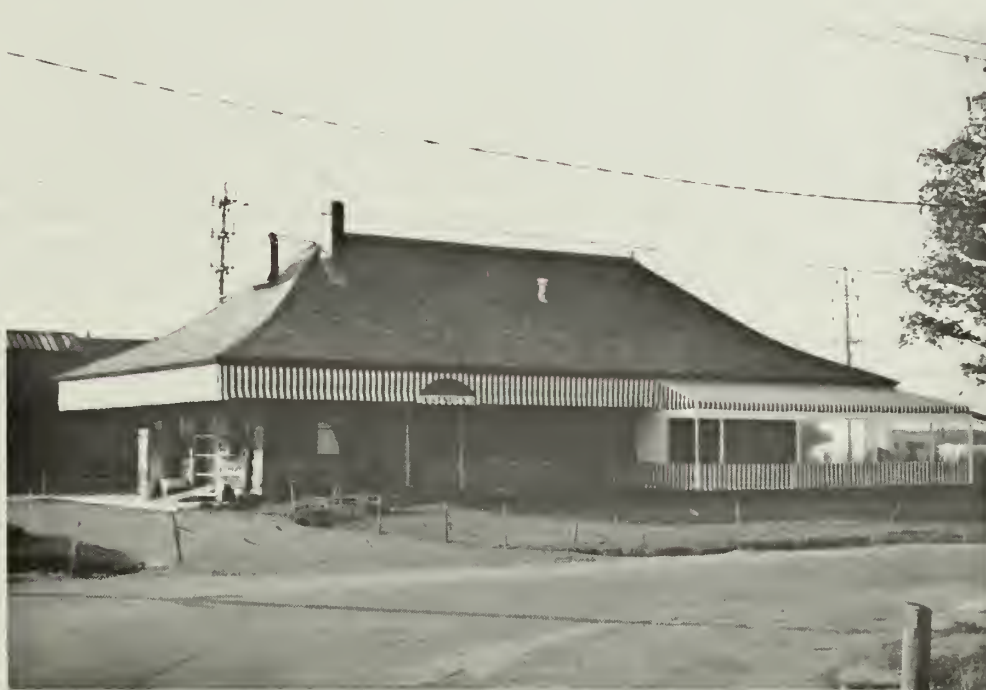
2. Post-rehabilitation view of the new addition and awnings from street. The addition and awnings obscure a substantial portion of the exterior.

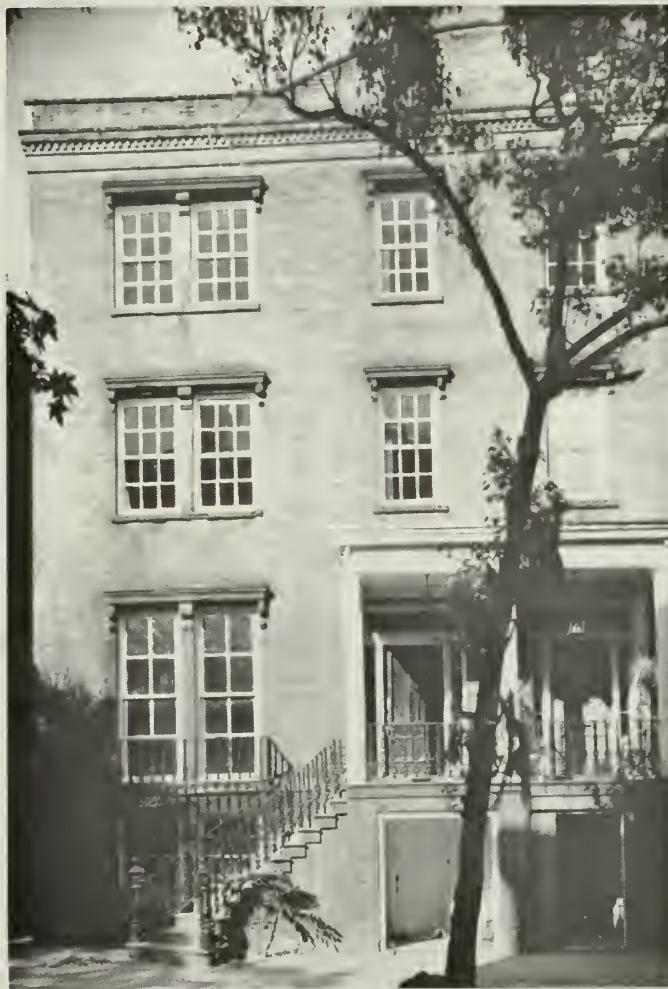
1. Building facade: This duplex rowhouse featured a formal series of 3 parlor rooms on the 2nd floor.

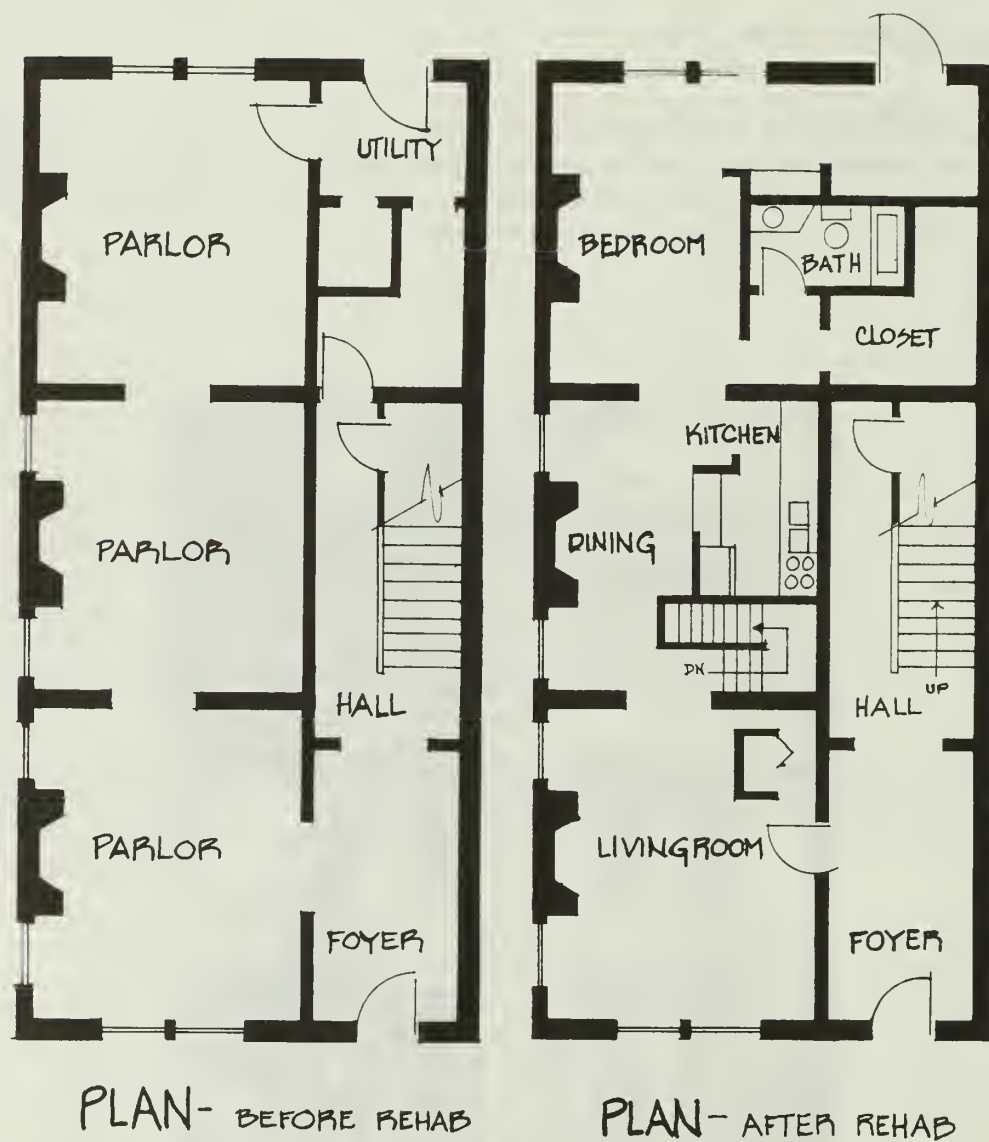
2. 2nd floor plan: Originally a side hall plan with 3 parlor rooms all of similar dimensions. Note extensive new construction in these rooms, especially stair and kitchen in center parlor room, and new wall for bathroom in rear parlor.

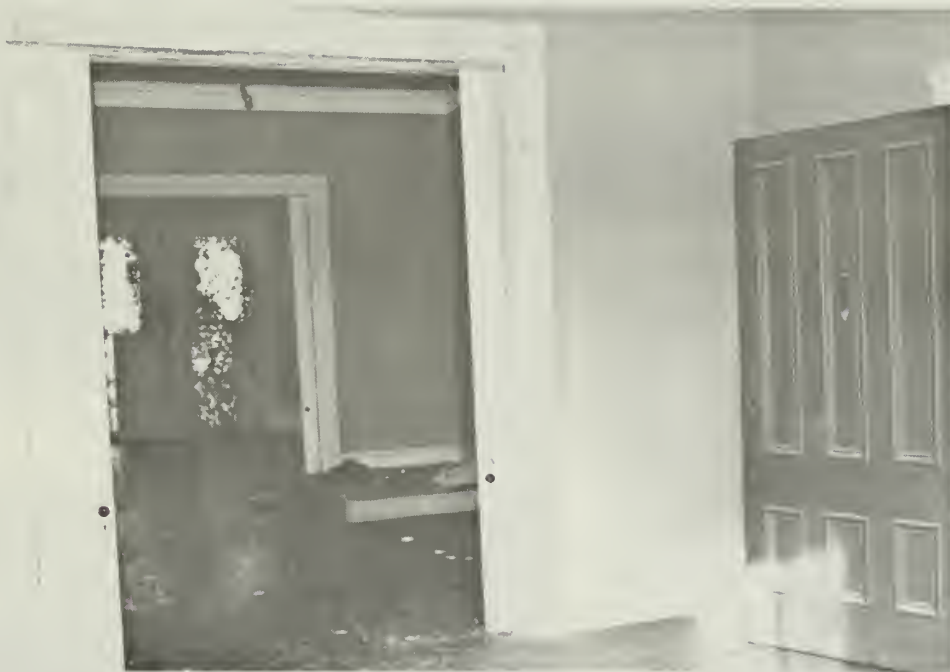
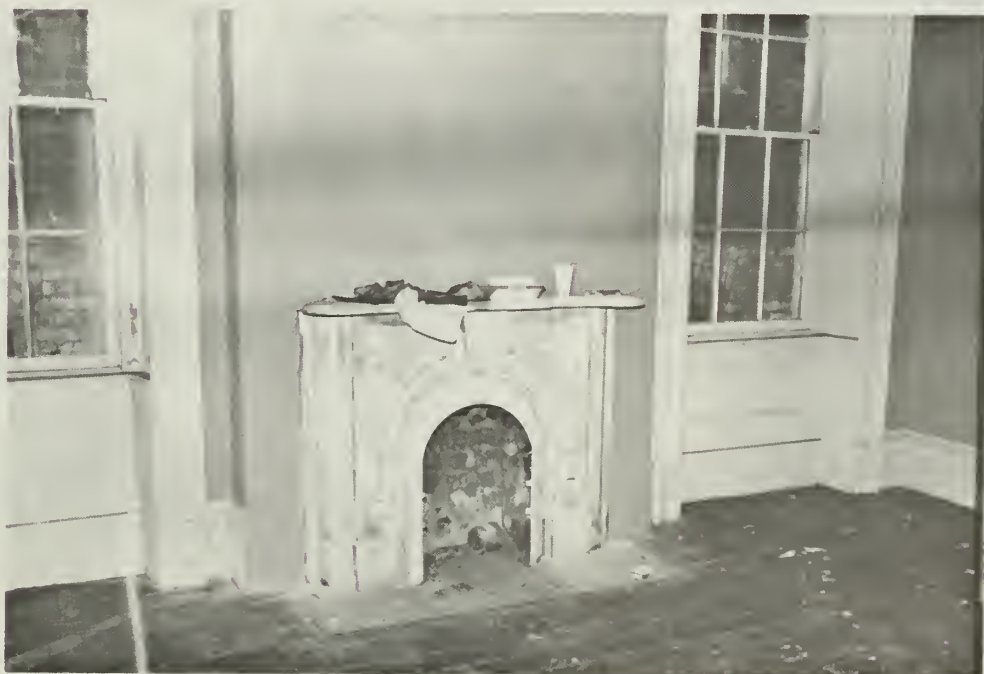
3 and 4. Pre-rehabilitation: 2nd floor.
Note view through 3 parlor rooms divided by pocket doors.
Center parlor room below now houses a staircase and kitchen.

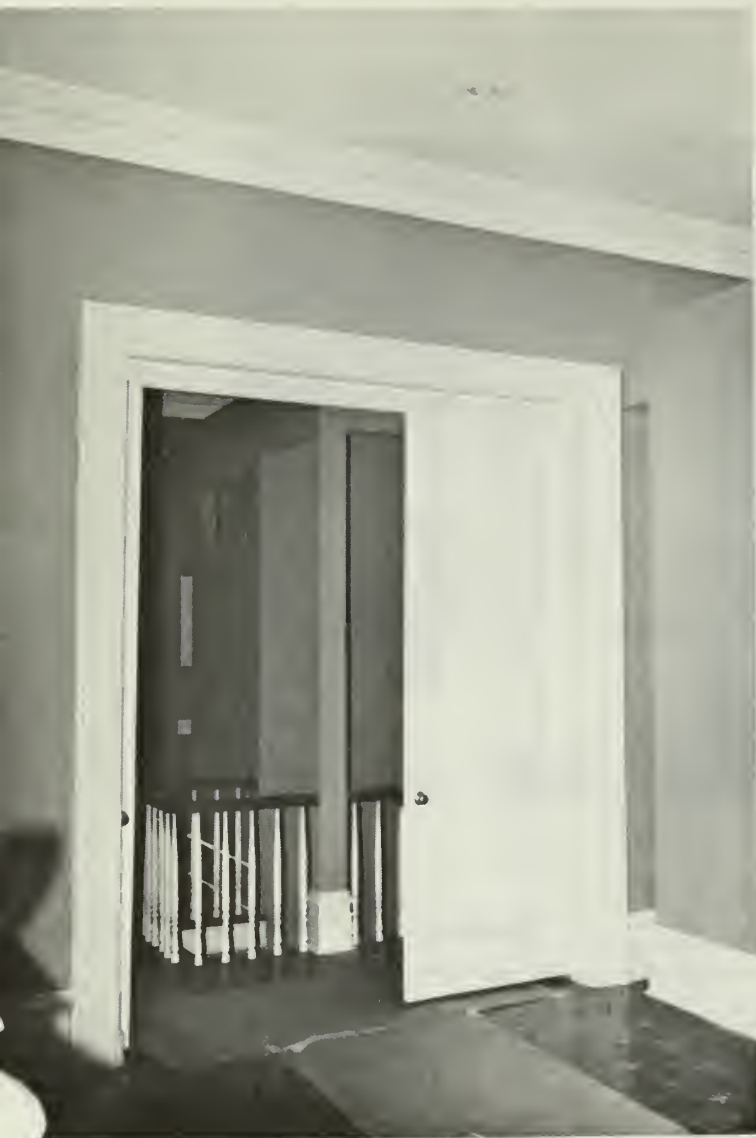
5. Post-rehabilitation: 2nd floor. Note new staircase and partition in center parlor room, new freestanding partition to the right of parlor door in front room.

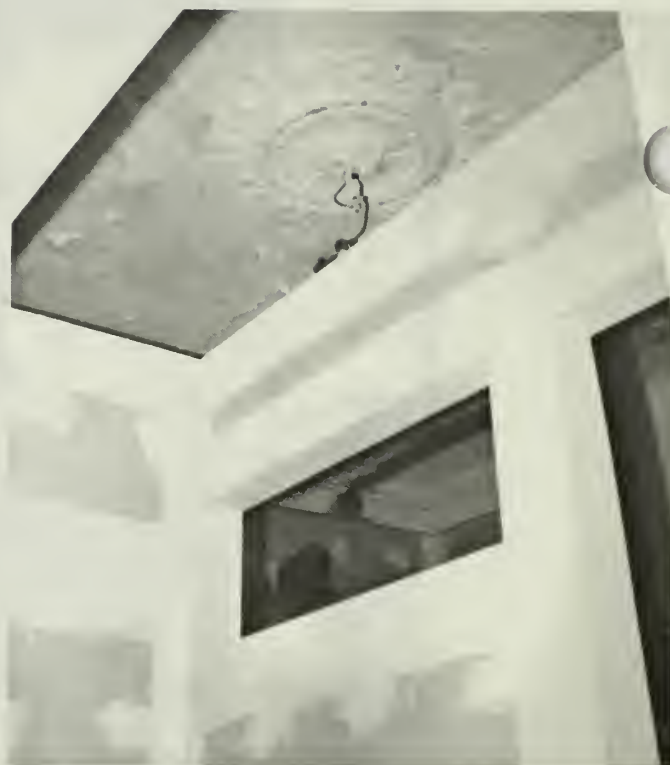
6. Work in progress: Center parlor. New partition wall for kitchen designed not to abut historic ceiling, yet is centrally located in room.

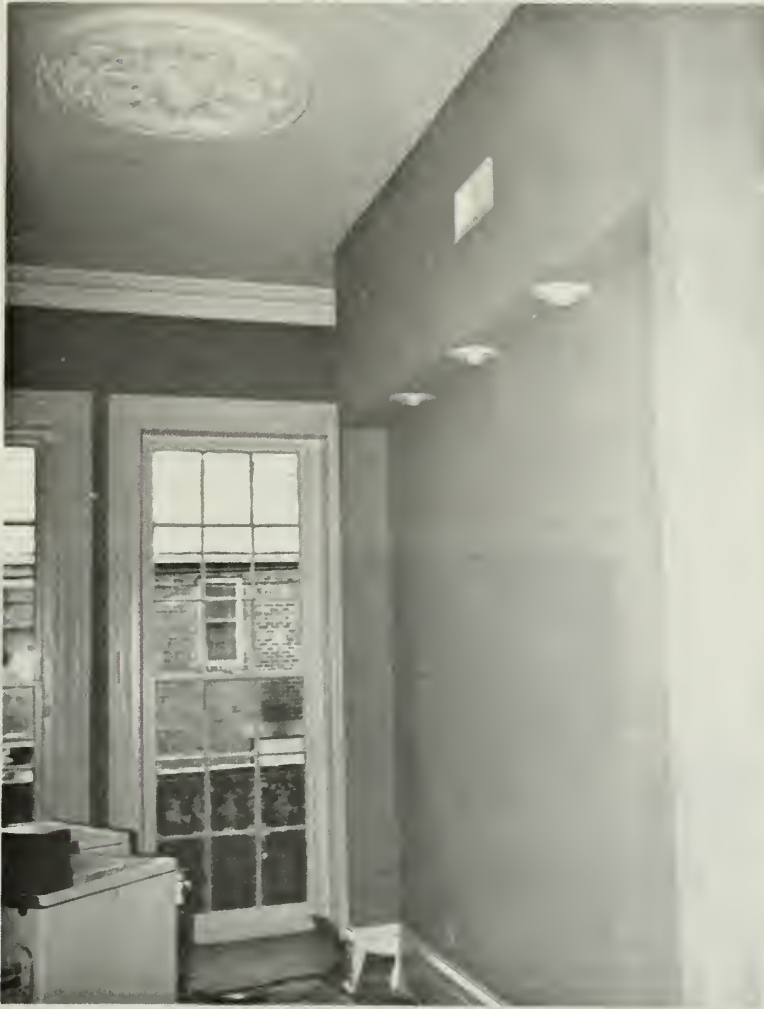
7. Post-rehabilitation: Rear parlor room.
New partition divides previously square room.

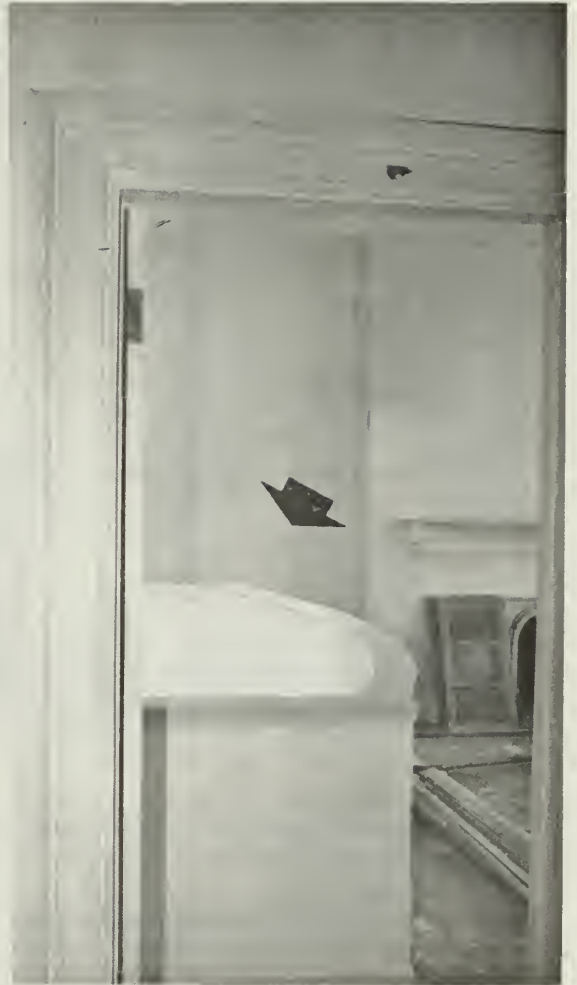
8 and 9. Fourth floor room,
pre-rehabilitation (left) and
in-progress (above). Note the
insertion of the new staircase
into the original bedroom in
the post-rehab view.

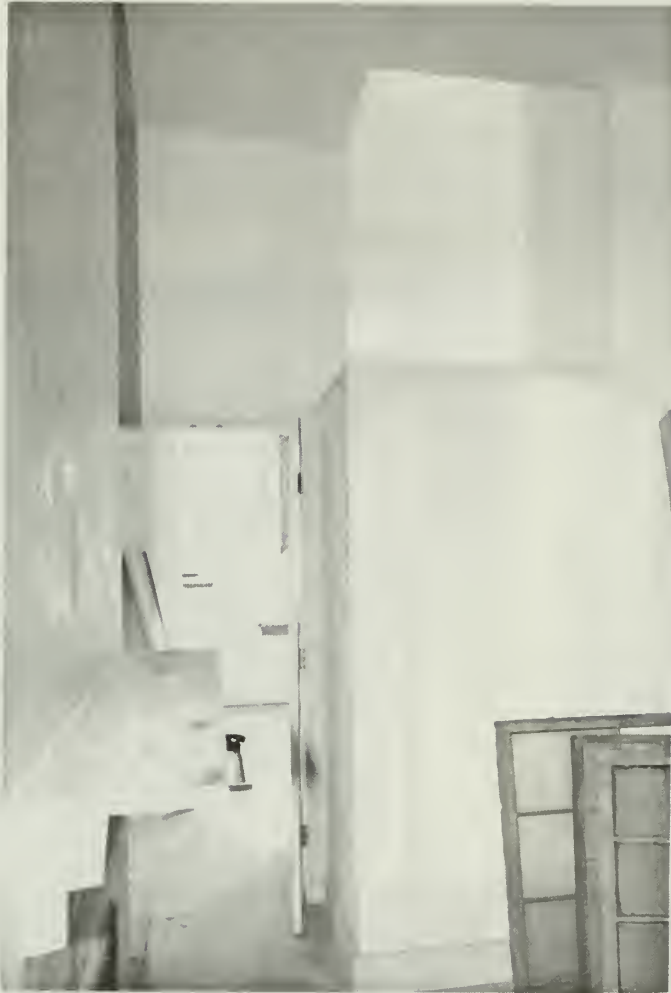
10. Work in progress on third floor showing penetration of wall between historic bedrooms, new staircase inserted in room and view to fourth floor above.

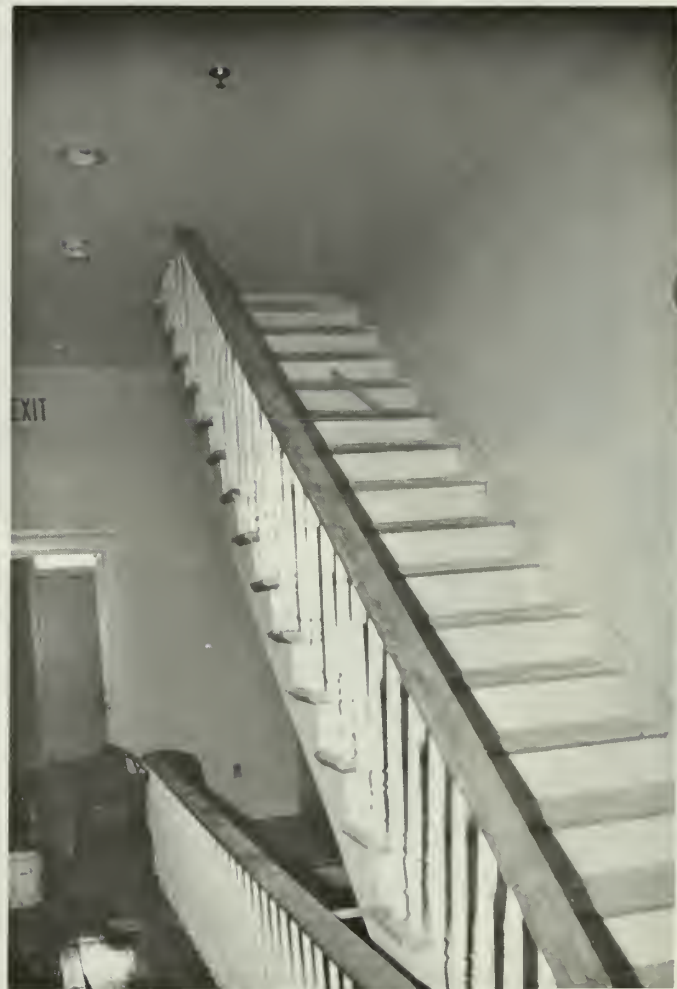
11. Post-rehabilitation view of original staircase maintained as a part of rehabilitation, but fourth floor is floored above, preventing access.

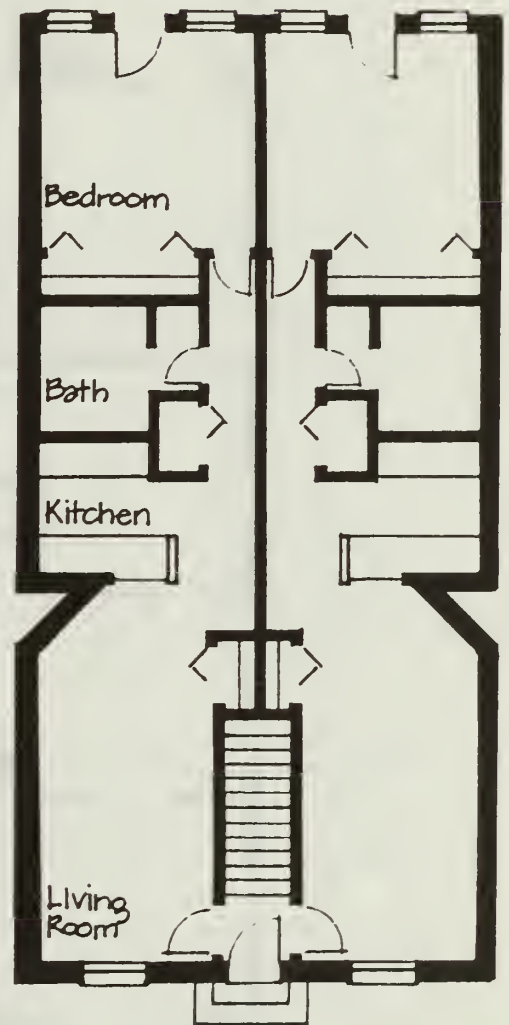
New Plan
1st Floor

2. New floor plan after rehabilitation shows that although lightshaft has been eliminated, basic concept of "railroad flat" remains.

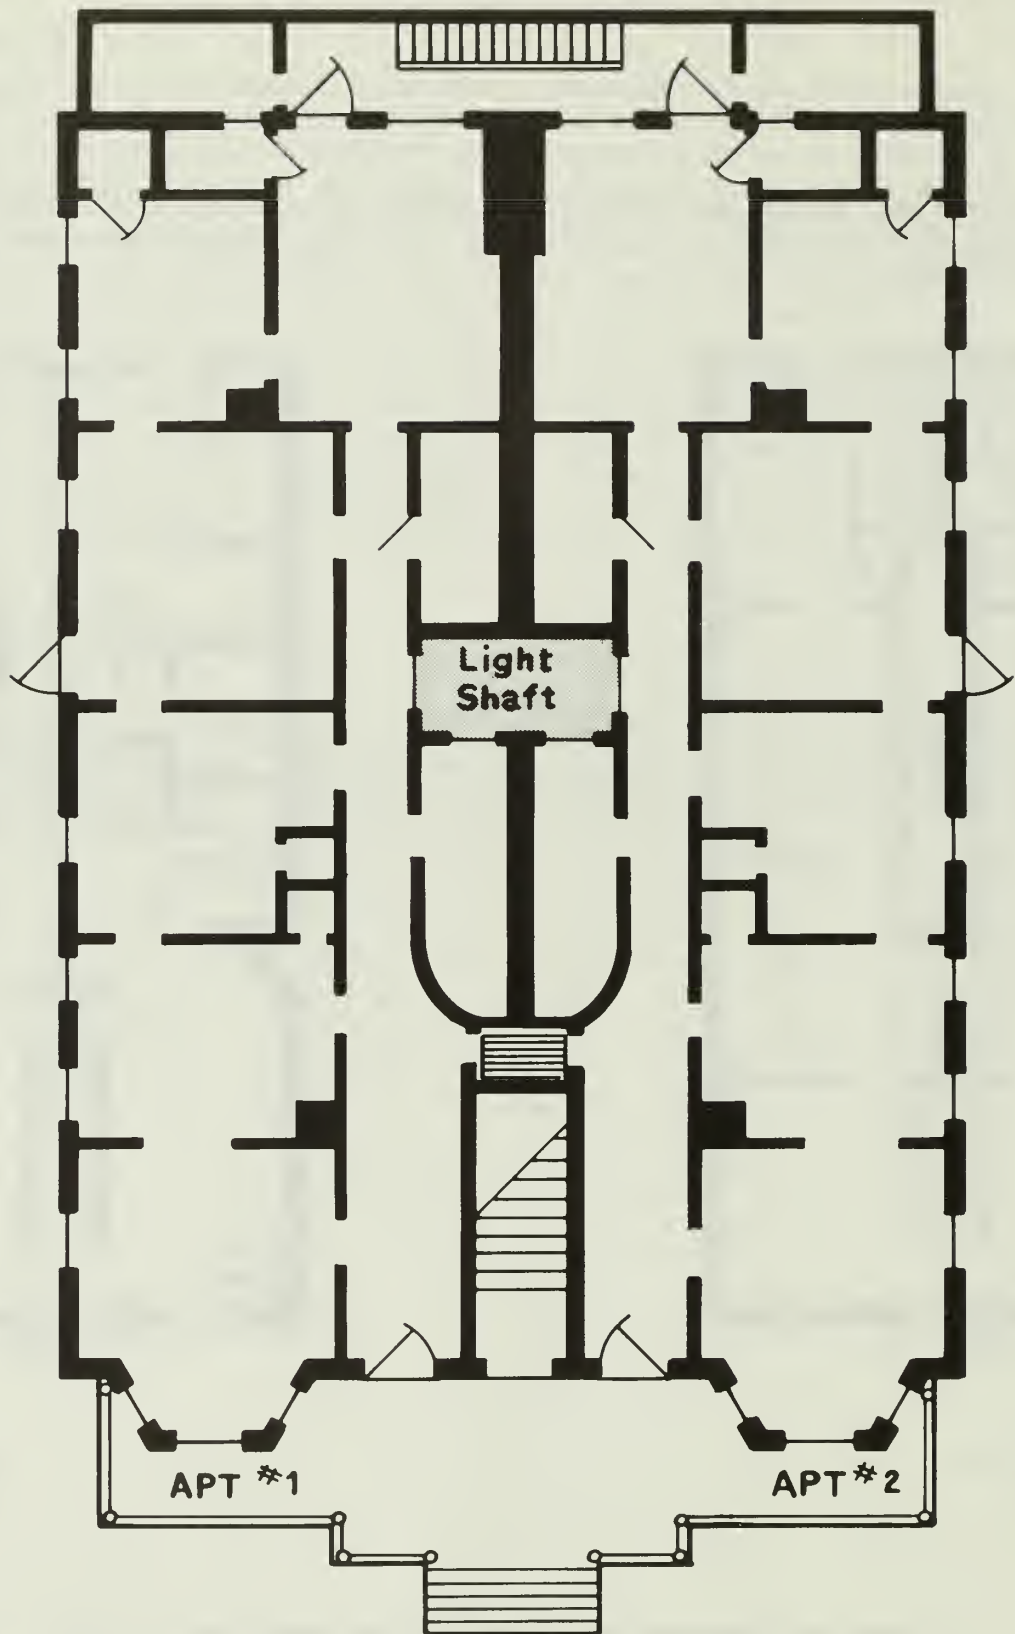
3. This original floor plan shows the lightshaft (shaded) that was determined not to be a character-defining feature and therefore eliminated in the rehabilitation of these two identical apartment buildings.

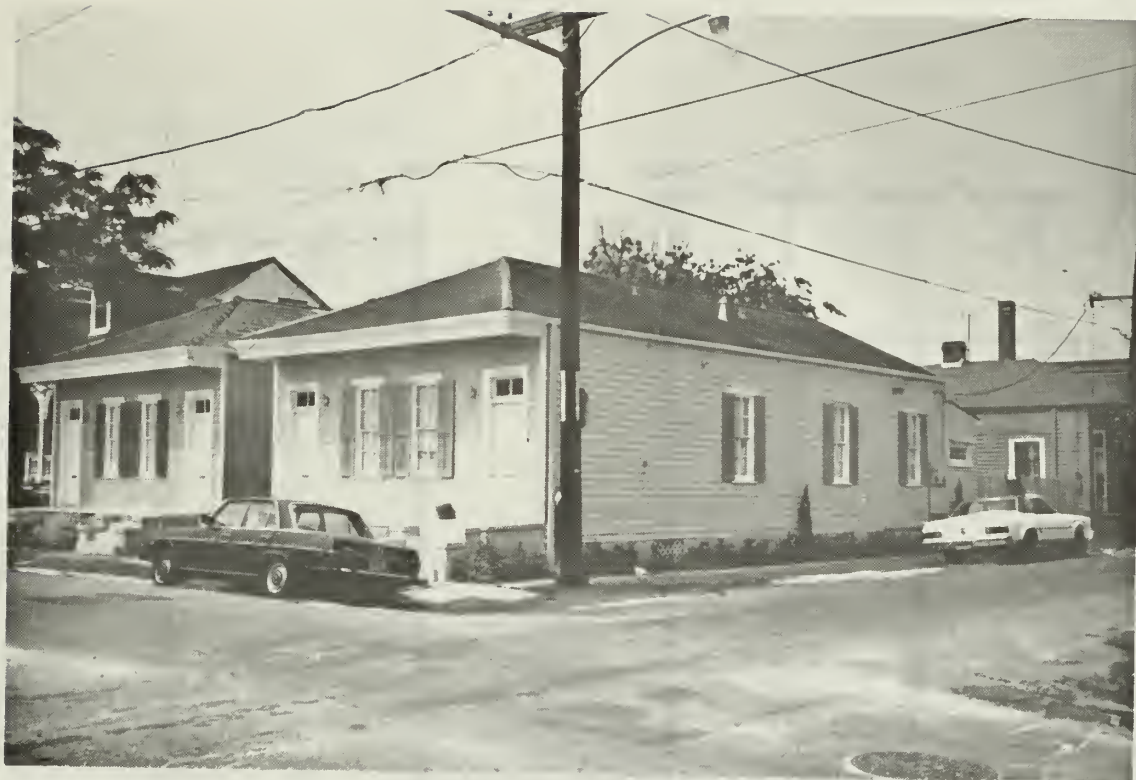
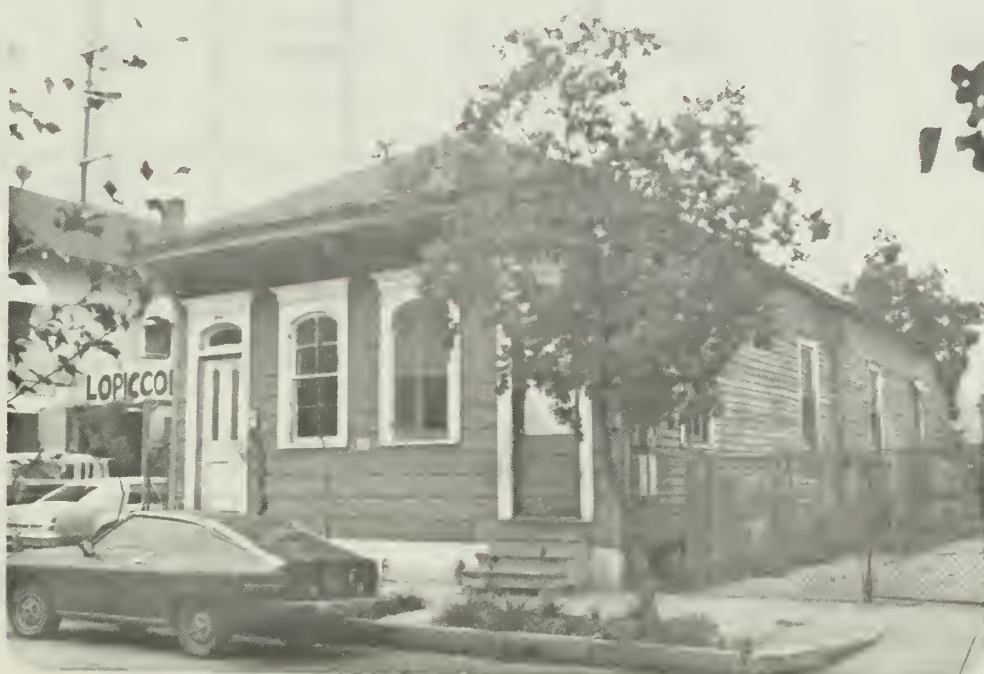
1 and 2. Circa 1900 double "shotgun" cottage (above) and circa 1890 double "shotgun" cottage.

Applications: Both projects discussed here are double "shotgun" cottages whose characteristic room arrangement remained intact despite some deterioration of features and finishes (see illus. 1 and 2). The first was built ca. 1900; the second dates from ca. 1890. The original plan of each building is a rectangle having a dividing party wall down the middle with four rooms arranged in linear fashion on each side. Sheds containing bathrooms had been added onto the rear of each building (see illus. 3 and 4). Each building was rehabilitated for continued use as residential apartments.
